## SE BaltEnergComfort

### Report on applying Isollat heat insulation coating in the heating unit and the adjacent wall in the apartment house in Kaliningrad, 6 Kronshtadskaya St.

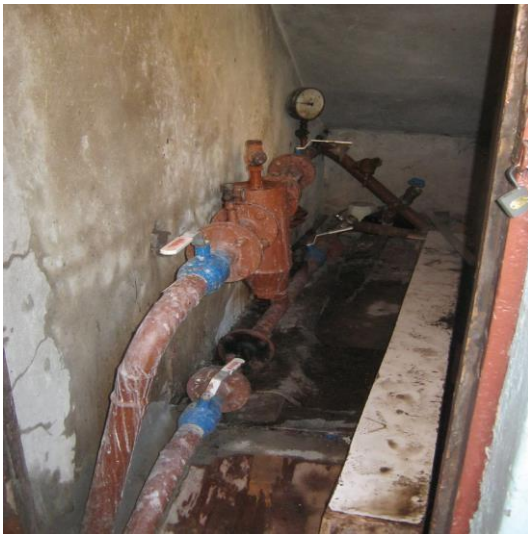
In flat No. 2 in the apartment house in Kaliningrad, 6 Kronshtadskaya St., the wall has been destroyed due to unfavourable climate condition during several years. It was discovered that during heating season the wall was overheated by the heating unit, and during offseason, it was covered with condensation and moisture penetrated into the apartment.

Photo and thermogram. Appearance and thermogram of the heating unit before applying Isollat coating.

To solve the problem, we decided to make hydro and thermal insulation of the dividing wall to eliminate condensation and to insulate it, as well as to cover pipes of the heating unit with "Isollat" coating.

The coating was applied with a brush on the separating wall from the heating unit side and to pipelines in two layers. The liquid heat insulation was reinforced with glass cloth on the pipes. Butt elements, valves were covered with Isollat coating on the cleaned metal. Heat insulation was applied to the hot pipes with temperature of 61.4°C. Temperature in the heating unit before applying Isollat was 36°C (see photo).

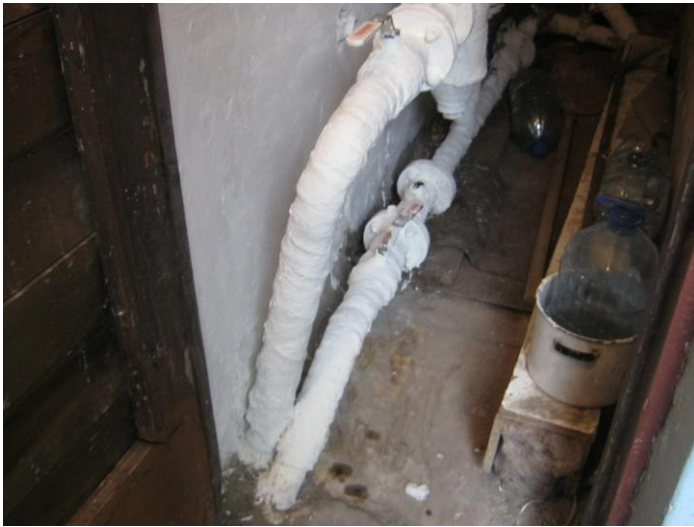
Photo and thermogram. Pipes treated with Isollat liquid insulation

After treatment, the pipes' temperature on the insulation made 26°C. Room temperature in the heating unit made 24°C. Average thickness of Isollat liquid insulation of 1.8 mm allowed isolating almost all emitting surface, including shut-off valves.

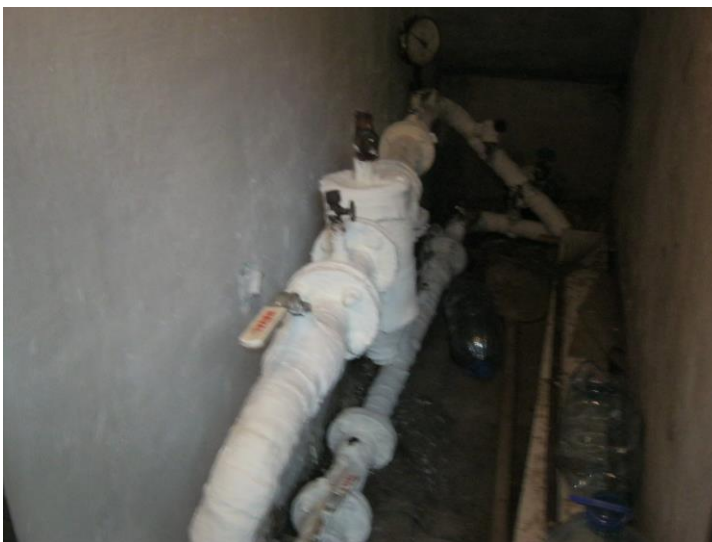
Photo and thermogram. Pipes treated with Isollat liquid insulation

Temperature of the wall in the apartment made 24°C, which is the same as temperature of all the walls in the room. Previously the wall was heated up to 40°C.
